Building WF16: construction of a Pre-Pottery Neolithic A (PPNA) pisé structure in Southern Jordan

Pascal Flohr¹, Bill Finlayson², Mohammad Najjar² and Steven Mithen³

Keywords Pre-Pottery Neolithic A, Wadi Faynan, Jordan, experimental archaeology, architecture

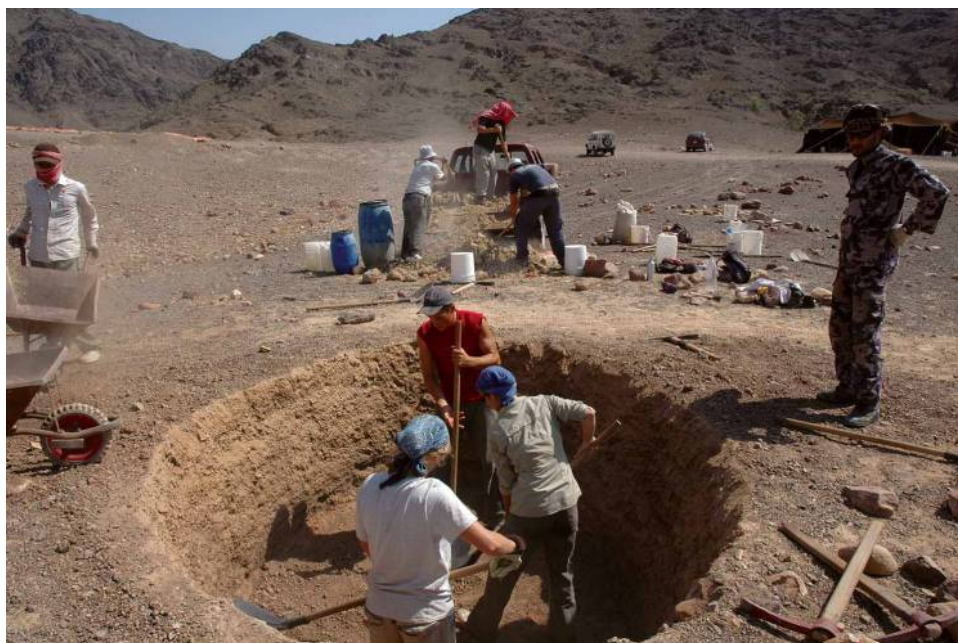
Figure 8 Digging of the pit, which measured 2.5 m × 3.5 m on top and was dug 1.2 m deep. In the background a load of sediment is unloaded. To the left, part of WF16 is visible.

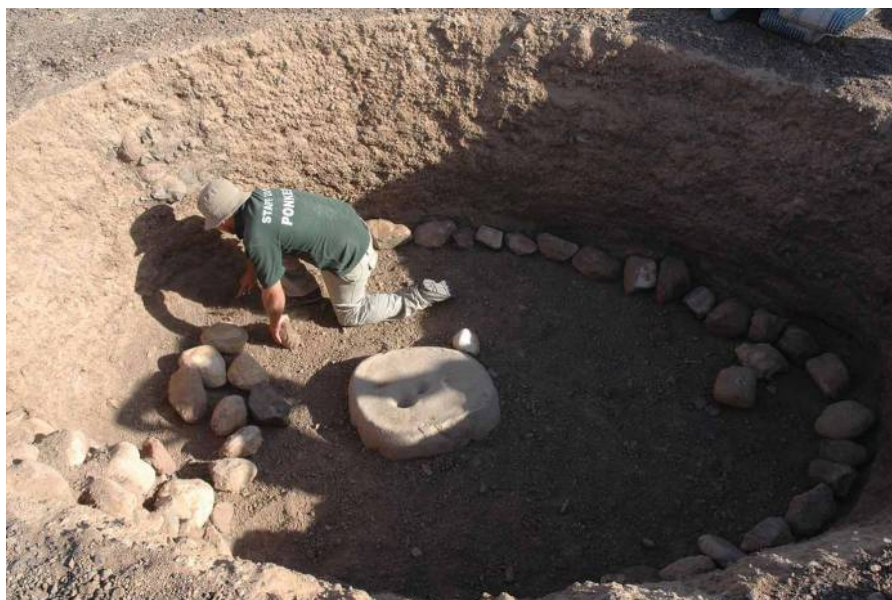
Figure 9 Laying of the foundation layer of boulders.

- (3) a foundation layer of boulders (each up to 0.2 m in length) was laid around the edge of the base of the cut (Fig. 9).
- (4) the stone foundation was covered with a first layer of the mud mix. When this layer was leather-hard, i.e. dry enough not to collapse when additional weight was applied, but not so dry that the next layer would not stick to it, a second layer was applied. This sequence was repeated until the top of the pit was reached, every time applying a layer of 10–15 cm (Fig. 10). Each layer, containing around 140–150 litres of mud, took three people around one hour to apply. Although individual members of the team developed their own preferences, in general the mud was applied by either kneading it in the hand and subsequently pressing it onto the wall, or by putting some mud on the wall and pressing hard into it. A niche was made within the wall

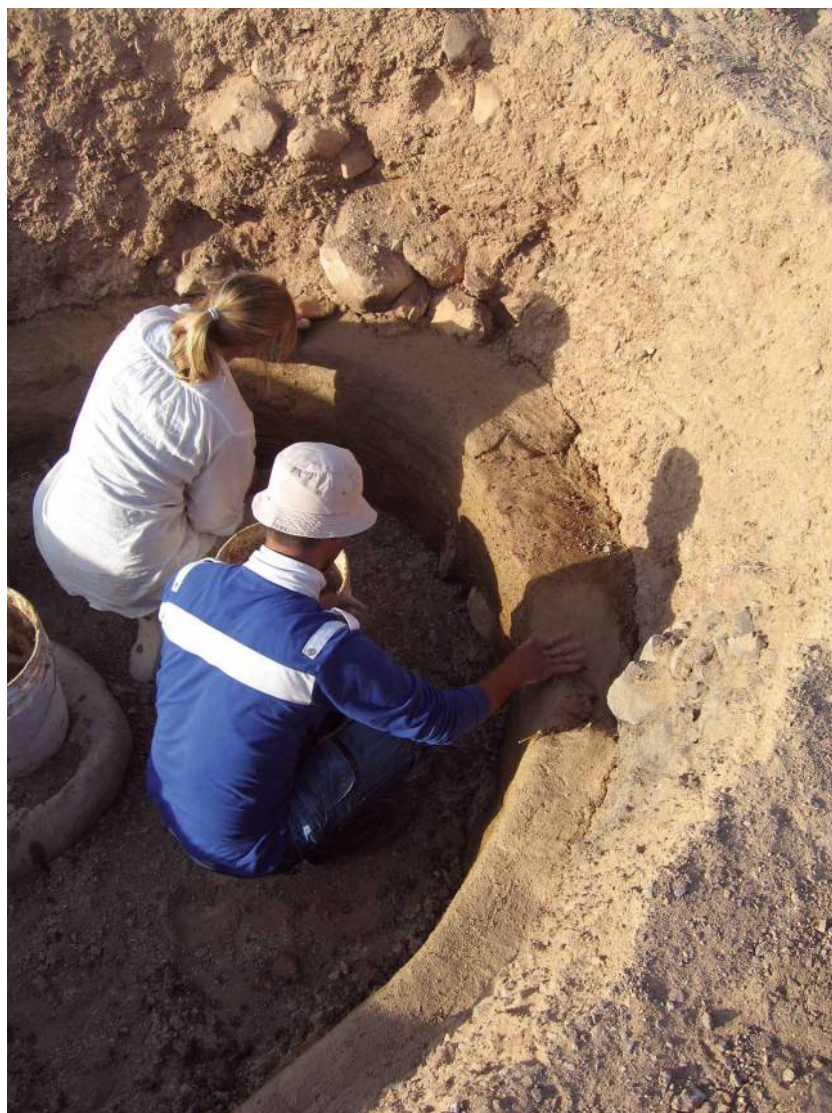
Figure 10 Application of wet pisé layers of 10–15 cm thick each.

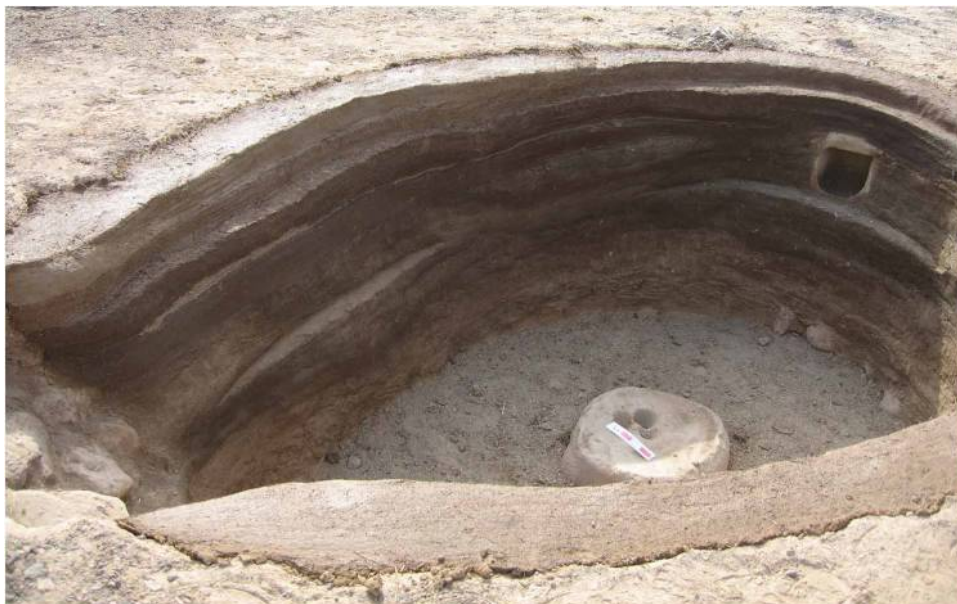
Figure 11 Stepping in of the southern wall, to avoid the wall becoming too thick as a result of bulging of wet walls and sloping edges of the pit.

with flat stones. When parts of the wall began to become too thick where they bulged inwards because of the weight of wet mud and because the edges of the pit cut sloped slightly outwards, the wall was realigned by stepping the next layer in. In the northern part this was done once, in the southern part twice (Fig. 11).

factors, it was decided to step the wall in. This was done twice in the southern, shaded part (Fig. 11), and once in the northern part. Interestingly, stepped walls had also been found in Structure O11 at WF16. These had been interpreted during excavation as indicating a realignment of the wall; the current study's experimental work suggests a simple pragmatic structural technique may have been responsible for this archaeological feature.

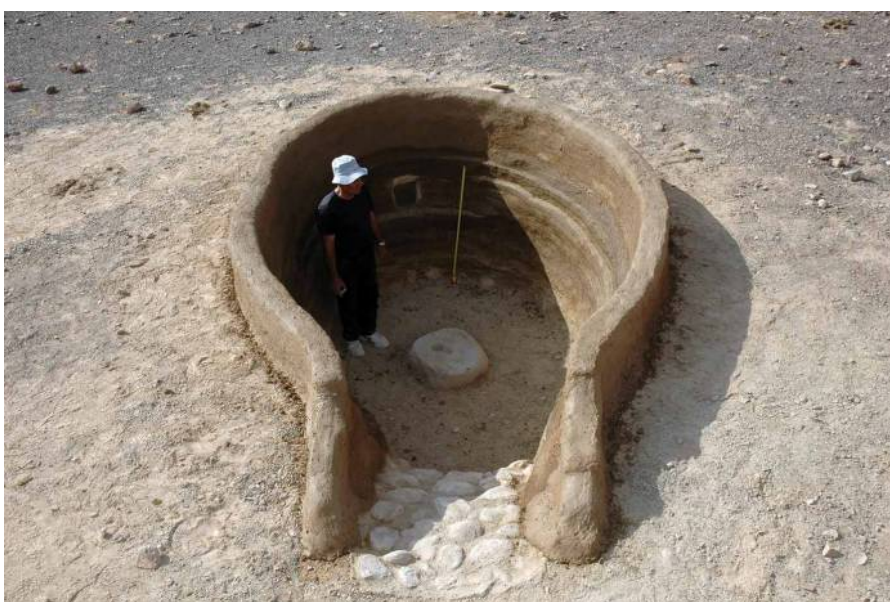
Figure 14 Finished wall with human scale and measurement tape (1 m scale).
